SOME SAFETY ISSUES INVOLVING INLAND WATER PASSENGER TRANSPORTS IN BANGLADESH

K. Hasegawa*, K. S. Iqbal*, and G. Bulian**

ABSTRACT

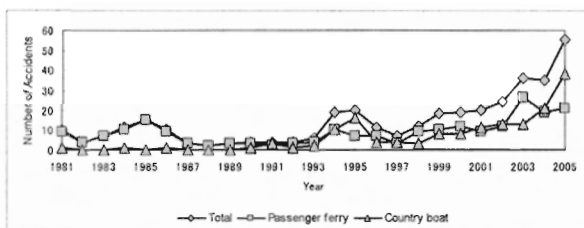
Fig. 1 Total number of accidents; by year

Analyzing Fig. 1, it was found that the frequency of accidents increased with time. This was obvious because the number of passenger vessels (motor launches) were increased with the increased demand from passengers, but the safety measures were not enough to accommodate all the new vessels in the fleet.

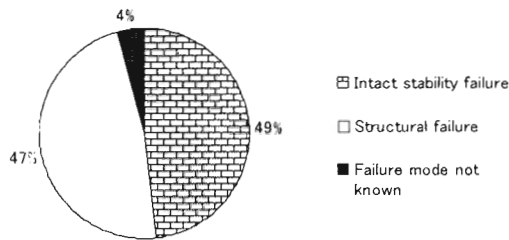
The modes of failure of passenger ferries are shown in Fig. 5. The causes that were mentioned in the reports as responsible for the structural failure of the passenger ferries are shown in the Fig. 6. The loading condition and the weather condition during the intact stability failure of ferries are shown in Figs. 7 and 8.

According to the figures about 49% of the total ferry accidents were due to intact stability failure, of which 36% cases were overloaded and loading condition in other 64% cases were not reported. Since, according to most relevant news reports, overloading is very common in Bangladesh, it would be logical to believe that most of the cases where loading condition was not known were actually

Fig. 5: Mode of passenger Ferry Accidents.

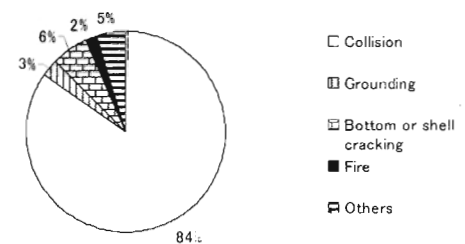
Fig. 6: Reported causes behind the structural failures

The collision was the main reason behind structural failure, where stormy wind and overloading/crowding to one side had severe effects on intact stability failure.

Collision was the severe cause behind Structural failure. These were the problems of proper management and ship operation. Strict monitoring of loading condition at ports and appointing skilled crews for ship operation could be effective measures to reduce such accidents as well as the loss of valuable lives. The navigable routes should also be marked with proper signals for various inland vessels.

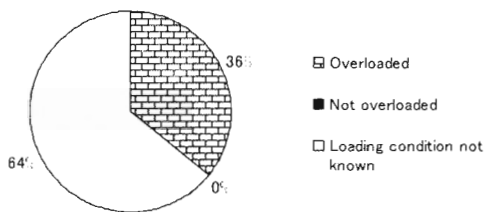
Fig. 7: Loading Condition of Ferries with Intact Stability Failure.

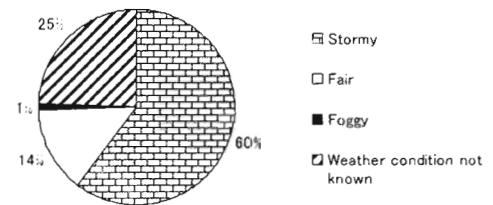
overloaded. Stormy weather condition was behind 60% of intact ship accidents. The weather condition was not reported for 14% of cases. These facts indicate that adverse weather condition and overloading were the main causes behind the intact stability failure of passenger ferries.

Fig. 8: Weather Condition during Intact Stability Failure of Ferries.

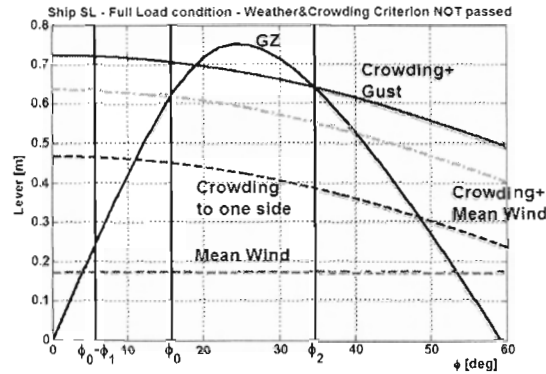
It was found that curtains are often present to protect people from wind and rain, significantly obstructing the available apertures on the ship side through which the wind could in principle flow. For this reason, in the criterion, openings on passenger decks should be considered closed or, at least, significantly obstructed. In the following calculation we will consider the openings as fully obstructed. For the crowding of passengers we have assumed, for this ship, a movement of 100% of the passengers onboard to a position equal to 70% of the half breadth of the ship. The application of the proposed criterion in the case of the "full load" condition is shown in Fig. 10, with numerical data provided in Table2: the ship cannot pass the criterion. It can thus be said that, from the application of the proposed criterion, the analyzed design should be considered as not satisfactory and potentially dangerous.

Fig. 10: Application of Weather & Crowding Criterion in the full load condition

ϕ_{fl}	ϕ_{ds}	ϕ_0	ϕ_1	ϕ_2	Area "a"	Area "b"	Passed?
58.8	18.2	15.7	10.0	34.6	0.049	0.013	NO
ϕ_{fl} : flooding angle; ϕ_{ds} : deck submergence angle; ϕ_0 : equilibrium angle under the action of steady wind and crowding to one side; ϕ_1 : assumed rolling amplitude; ϕ_2 : minimum between 50deg, the angle of vanishing stability and the flooding angle; Angles are measured in [deg] and areas in [m*rad].

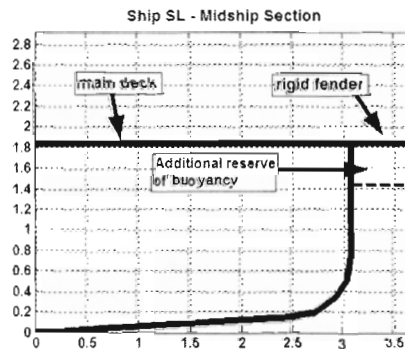
Fig. 11: Rigid fender at the midship section.

The basic idea is to supplement the ship with an additional reserve of buoyancy above the waterline, in such a way to increase, especially, the maximum \overline{GZ} . Typical passenger ferries operating in Bangladesh are fitted with a rigid fender at height of the deck, extending transversally with a length depending on the particular ship. For the ship under analysis, the breadth of such fender is 0.6m, as shown for the midship section in Fig. 11. Such rigid fender is used to protect the ship hull during berthing and during loading/unloading operation.

The idea is thus to provide additional buoyancy to the ship by exploiting the clear area below the fender. The requirements for the ship modification are:

We have thus considered the possibility of adding such buoyancy through totally enclosed inflatable lifting bags, to be fit in position under the rigid fender. Such buoyancy aids could be easily filled with air by means of an air pump connected to the main engine. In addition to providing additional buoyancy, they could be also considered effective as protections from collisions, thus increasing the inherent ship safety with respect to this latter hazard. Moreover, in case of breach of the hull, the presence of such bags, if not damaged, could provide a safe, though limited, additional reserve of buoyancy.

The selection of the dimensions of such buoyancy reserve is governed by the actual breadth of the fender and by the freeboard at the maximum allowed draught. The ship under analysis has a maximum allowed draught of 1.2m, with a depth of 1.83m. If we assume that 0.2m should be left clear between the waterplane and the bottom of the lifting bags, a maximum height of about 0.4m is obtained. It is to be said that such height could be increased by reducing the maximum allowed draught: the reduction in the maximum payload that the ship could carry would be compensated by the additional safety. The geometry and the position of the additional reserve of buoyancy are shown in Fig11.

The intact stability of the contemporary inland passenger ferries in Bangladesh can be improved by fitting some additional buoyancy under the rigid fender of the ferries.

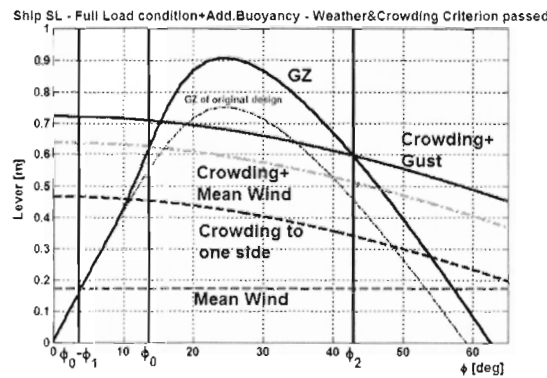
In order to check the effectiveness of the proposed modification on a rational basis, we have again applied the proposed "Weather&Crowding" criterion to the modified ship at the full load condition. The results of the application are shown in Fig. 12 and Table3 where it can be seen that the modified ship is able to fulfill the requirements thanks to the additional restoring. For sake of comparison, in Fig. 12, the \overline{GZ} curve of the original design is also reported. Therefore, from the obtained result, it seems that the proposed modification is worthy attention, due to its potential of improving the safety of the

It is however important to underline that the proposed modification, although providing an improvement with respect to the original design, is not able to solve the issue of concurrent crowding to one side and gust in the overloaded condition. In the 50% overloaded condition, in fact, there is no intersection between the \overline{GZ} curve and the lever of the moment due to crowding and gust, even after the fitting of the additional buoyancy reserve. A stable equilibrium angle of 18.7deg is found, on the other hand, if the gust effect is omitted: without the fitting of additional buoyancy, as already said, the ship would have statically capsized also in such situation.

Fig. 12: Application of Weather & Crowding Criterion to the modified SL at full load condition.

ϕ_{fl}	ϕ_{ds}	ϕ_0	ϕ_1	ϕ_2	Area "a"	Area "b"	Passed?
64.8	19.1	13.7	10.0	42.9	0.060	0.072	YES
