Passenger Ferry Accidents in Bangladesh: Design and Socio-economic Aspects

The safety of inland passenger vessels operating in Bangladesh has been investigated. By thorough analysis of the past accidents' data, the main cause behind structural failure has been found as collision. The main causes behind intact stability failures have been determined as adverse weather conditions and overloading, with consequent likely crowding to one side. Historical series of wind data were gathered and their analysis suggests that an increase of the wind speed presently used in the Weather Criterion in force in Bangladesh could be advisable. A small passenger ship, of the type typically operated in Bangladesh, has been analyzed. A strongly jeopardizing effect of the overloading on intact ship condition has been detected when analyzing the hazard of crowding of passengers to one side.

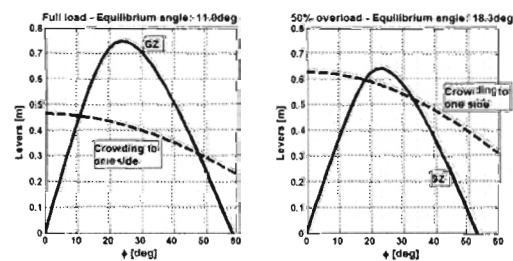
Figure 2: Heeling moment due to passenger crowding.

The calculated heeling moment due to passengers crowding to one side is significant (see Figure 2). In particular the situation is critical in the overloaded condition, where the increased weight of the passengers onboard leads to an equilibrium angle of more than 18 degrees, and, more important, to a residual range of stability that is very small, with an also very small maximum residual \overline{GZ} . In the overloaded condition, the ship can be in extreme danger during crowding of passengers to one side if some additional heeling cause, like the expected presence of wind, is introduced. It is important to note that, due to the very large B/T ratio of the ship under analysis, the \overline{GZ} curve shows, in both cases, a maximum at relatively small heeling angles despite the large metacentric height.

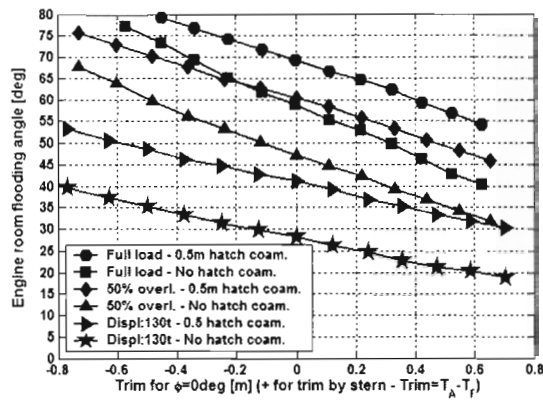
Figure 4: Angle of submergence of the hatch leading to flooding of engine room in case of absence of hatch cover.

Such hatch should be closed, however it has often found to be opened in operation, thus representing, in principle, a potential progressive flooding means. In some designs the hatch is provided with hatch coamings of a not negligible height above the deck, whereas in other cases hatch coamings are, practically, not present. We have thus analyzed the angle at which the engine room starts flooding depending on whether a hatch cover is fitted or not. A representative height of 0.5m above the main deck has been considered for the hatch coaming and the effect of the initial trim has also been investigated. From the results shown in Figure 4 we can conclude that:

- Trim by stern should be carefully controlled;
- The fitting of sufficiently high hatch coamings as a significant positive effect;
- For the two basic loading conditions the downflooding angle is, in general, quite large. The same cannot be said for the ship sailing at the maximum draught.

room is about 41deg with the presence of hatch coamings with 0.5m height, and about 28deg in absence of hatch coamings for a zero trim condition in calm water (see Figure 4). The deck submergence angle is significantly small, and equal to 11.8deg with zero trim. In the case of deck submergence, the change of trim has a limited effect.

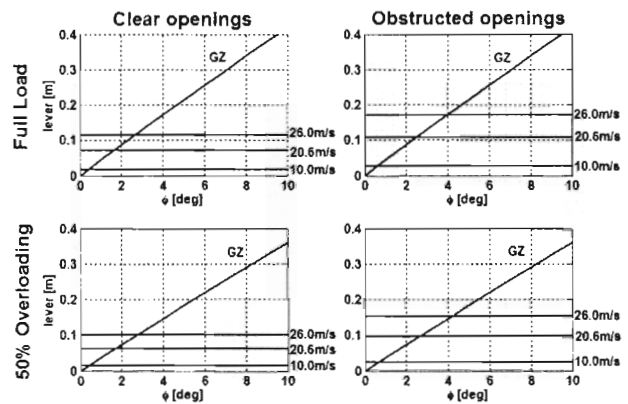
Figure 5: Analysis of the effect of beam steady wind.

The results of the analysis are reported in Figure 5: the effect of the wind is, despite the quite large exposed area, not very significant and the equilibrium angle in the worst considered case slightly exceeds 4deg. This is due to the large metacentric height in the considered loading conditions. The wind itself, for not too extreme speeds, seems thus not to be a very dangerous hazard able to capsize the ship without the concurring effect of other heeling causes. Nevertheless it is important to pay attention at the large of variation of the heeling moment due to wind depending on the assumptions used. Globally, if we consider the best and the worst case, we find a ratio of about 10.2 between the corresponding heeling levers, and, thus, the corresponding heeling angles. In view of the analysis of the wind carried out in this research, and considering the quite common bad habit of fixing the curtains at the side openings, it would seem more reasonable to consider, in the stability assessment framework, the openings as obstructed and a wind speed of 26m/s.

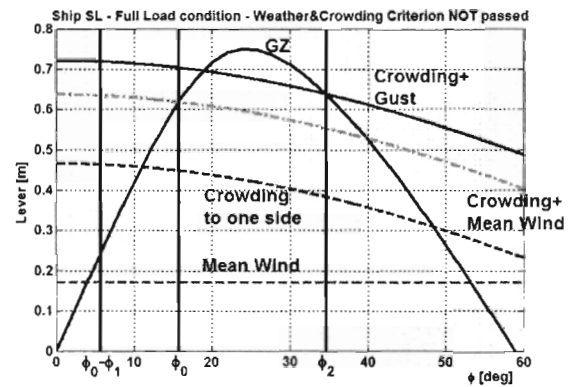
Figure 6: Application of Weather & Crowding Criterion in the full load condition.

For the crowding of passenger we have assumed, for this ship, a movement of 100% of the passengers on-board to a position equal to 70% of the half breadth of the ship. The application of the proposed criterion in the case of the "full load" condition is shown in Figure 6, with numerical data provided in Table 4: the ship cannot pass the criterion. In addition, due to the small angle of deck submergence (slightly above 18deg), the requirement of a steady equilibrium angle below 80% of the

deck submergence angle or 16deg, whichever the less, cannot be fulfilled. In the overloaded condition, the situation is even worse, because the ship cannot even statically sustain the combined effect of crowding to one side and mean wind (as it is clear from the results given in Figure 2 and Figure 5). It can thus be said that, from the application of the proposed criterion, the analyzed design should be considered as not satisfactory and potentially dangerous.

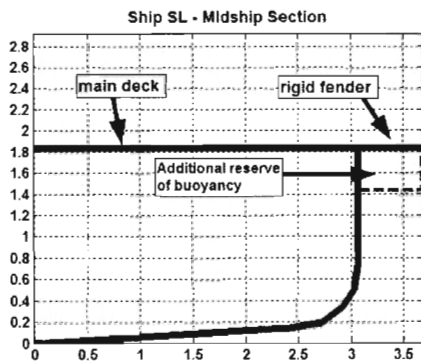
Figure 7: Rigid fender at the midship section.

The basic idea is to supplement the ship with an additional reserve of buoyancy above the waterline, in such a way to increase, especially, the maximum \overline{GZ} . Typical passenger ferries operating in Bangladesh are fitted with a rigid fender at height of the deck, extending transversally with a length depending on the particular ship. For the ship under analysis, the breadth of such fender is 0.6m, as shown for the midship section in Figure 7. Such rigid fender is used to protect the ship hull during berthing and during loading/unloading operation (and it is not uncommon, unfortunately, to see people standing on it).

We have thus considered the possibility of adding such buoyancy through totally enclosed inflatable lifting bags, to be fit in position under the rigid fender. Such buoyancy aids could be easily filled with air by means of an air pump connected to the main engine. In addition to providing additional buoyancy, they could be also considered effective as protections from collisions, thus increasing the inherent ship safety with respect to this latter hazard. Moreover, in case of breach of the hull, the presence of such bags, if not damaged, could provide a safe, though limited, additional reserve of buoyancy.

The selection of the dimensions of such buoyancy reserve is governed by the actual breadth of the fender and by the freeboard at the maximum allowed draught. The ship under analysis has a maximum allowed draught of 1.2m, with a depth of 1.83m. If we assume that 0.2m should be left clear between the waterplane and the bottom of the lifting bags, a maximum height of about 0.4m is obtained. It is to be said that such height could be increased by reducing the maximum allowed draught: the reduction in the maximum payload that the ship could carry would be compensated by the additional safety. The geometry and the position of the additional reserve of buoyancy are shown in Figure 7.

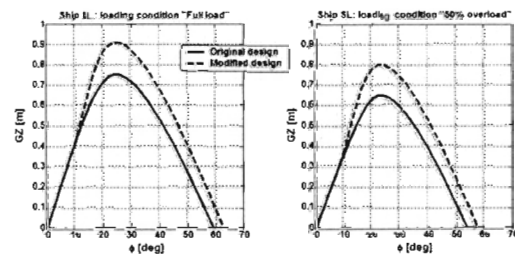
Figure 8: \overline{GZ} curves for the ship SL in the two tested loading conditions for the original and the modified design.

Figure 8 reports the comparison of the \overline{GZ} curves for the ship SL in the original and modified configuration, for the two tested loading conditions: the improvement in the \overline{GZ} curve for the two tested loading conditions is evident. The maximum still occurs at quite low heeling angles, however the value of the maximum has been increased, on average, by about 22%.

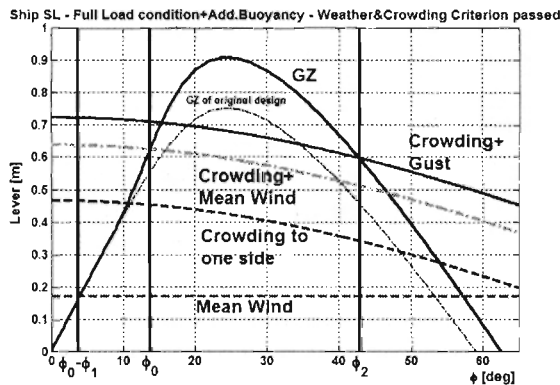
Figure 9: Application of Weather&Crowding Criterion to the modified SL at full load condition.

application are shown in Figure 9 and Table 5, where it can be seen that the modified ship is able to fulfill the requirements thanks to the additional restoring. For sake of comparison, in Figure 9, the \overline{GZ} curve of the original design is also reported. Therefore, from the obtained result, it seems that the proposed modification is worthy attention, due to its potential of improving the safety of the considered ship with limited efforts.
