NATECH2016
January 12-13, 2016
Nakanoshima Center of Osaka University

SEISMIC RESISTANCE CAPACITY ON PIPE BRACED SUPPORTING FRAME OF SPHERICAL TANK

Takashi OHNO
The High Pressure Gas Safety
Institute of Japan (Graduate
School of Aoyama Gakuin
University)

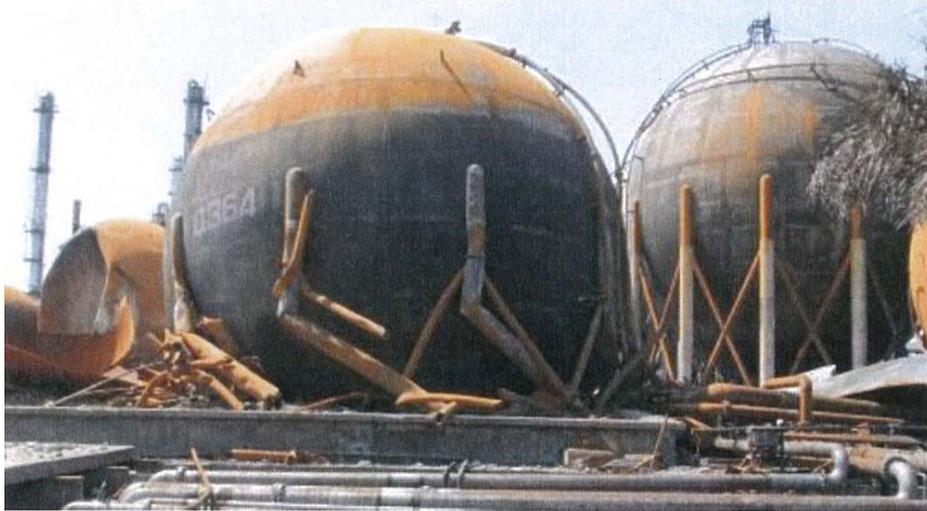
Accident 1

Collapsed spherical tank

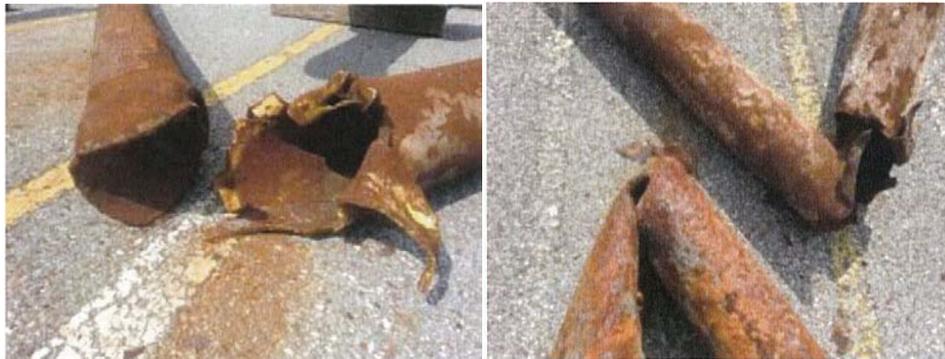
Steel pipe brace breaking

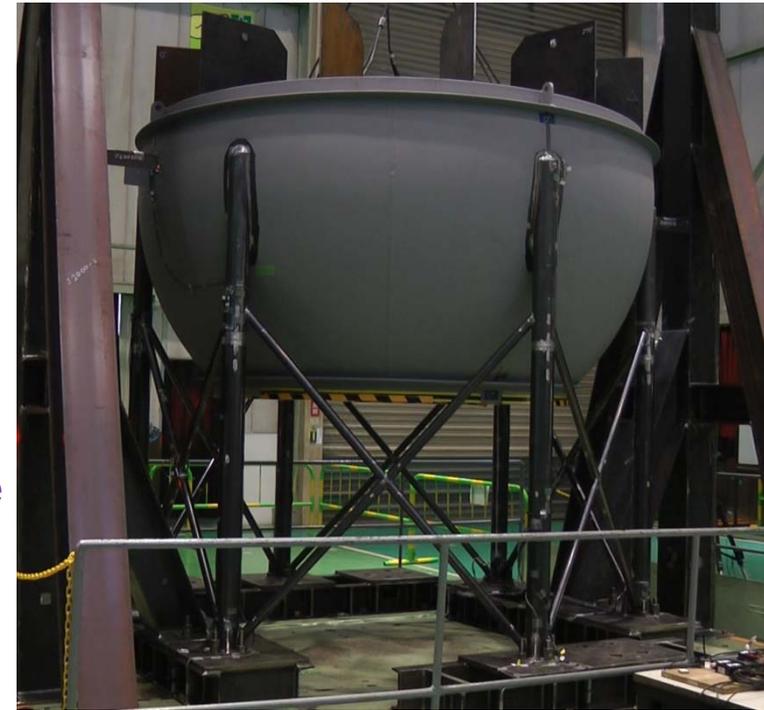
- Acceleration. and duration time with similarity rule
- Cut off long term period with high pass filter(2.8Hzz)
- Simulated seismic wave fit on acceleration spectrum for design

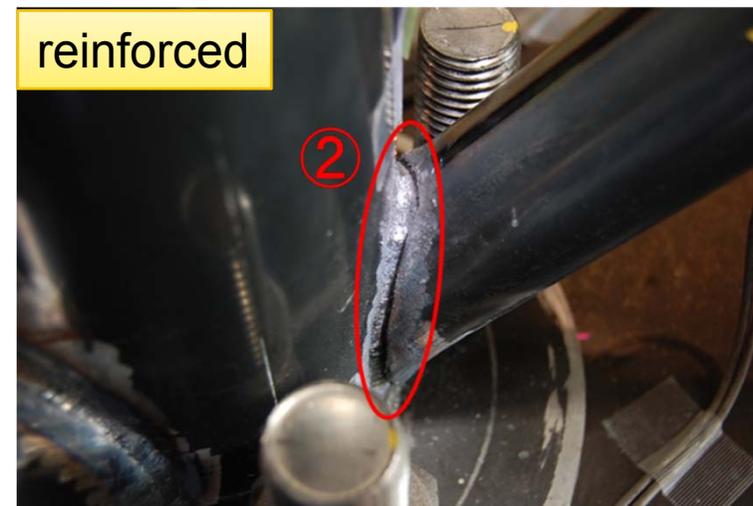
Broken brace around weld joint with lower column

- (1) In a case of brace intersection was reinforced, the maximum response acceleration increased at collapse.**
- (2) In a case of there was reinforced there is no reinforcement to brace intersection, structural strength indicated the lowest at the load direction acting tensile force on long brace, cross section of long brace were deformed largely.**
