SOME SAFETY ISSUES INVOLVING INLAND WATER PASSENGER TRANSPORTS IN BANGLADESH

K. Hasegawa*, K. S. Iqbal*, and G. Bulian**

ABSTRACT

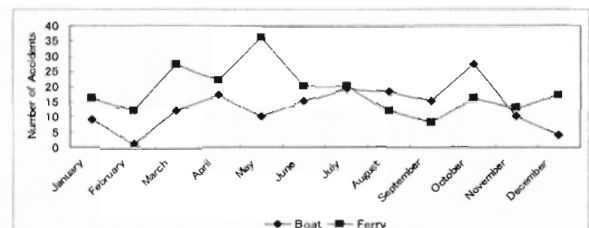
Fig. 2: Total number of accidents; by months

Fig. 4 show that May was the most vulnerable period for accidents. March and October were the next. These were the periods when storms, tornadoes and cyclones hit Bangladesh very frequently. At that time the wind blew with much higher speed than the speed that was usually considered during the design of vessels. Moreover overloading and crowding effect accelerated the capsizing by reducing the stability. Though there were regulations for not operating vessels during the storms, it was often violated. During storms the visibility became worse, vessels controlling became difficult due to high wave and strong wind. So many times the crews could not avoid collision in the river channel leading to structural failure and capsizing/sinking.

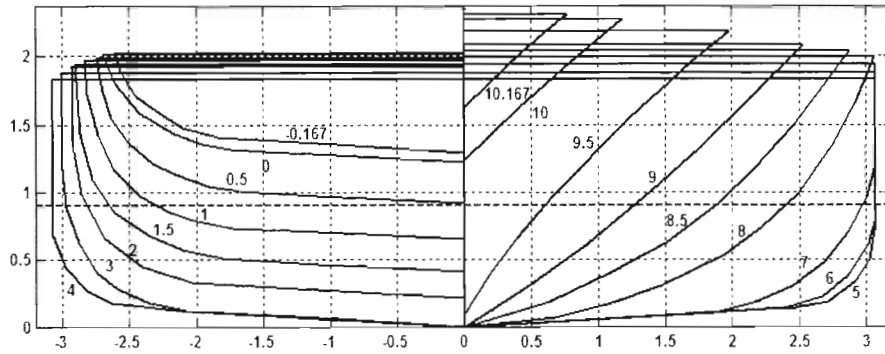
Fig. 9: Body-plan of the model ship

To analyze the intact stability failure of the ferry, a model ship, similar to one that capsized in Bangladesh, was taken into consideration and a weather & crowding criterion was checked with that model. The body-plan of the model is shown in Fig. 9. The reference loading condition are given in Table 1.

The Weather Criterion presently in force in Bangladesh (Zulfikar, 2005) only considers the effect of beam wind. In the authors' opinion, a compliance with such a criterion does not necessarily lead to a sufficiently safe ship, due to the lack in acknowledging the possible detrimental effect of the crowding of passengers to one side. In addition, the pressure to be taken into account in the present criterion is about 1.6 times smaller than the pressure that should be accounted for if a mean wind speed of 26m/s would be considered. We would like to recall that very localized storms (tornadoes) are not uncommon in Bangladesh, and they can be associated to much higher wind speeds than 26m/s.
