Passenger Ferry Accidents in Bangladesh: Design and Socio-economic Aspects

The safety of inland passenger vessels operating in Bangladesh has been investigated. By thorough analysis of the past accidents' data, the main cause behind structural failure has been found as collision. The main causes behind intact stability failures have been determined as adverse weather conditions and overloading, with consequent likely crowding to one side. Historical series of wind data were gathered and their analysis suggests that an increase of the wind speed presently used in the Weather Criterion in force in Bangladesh could be advisable. A small passenger ship, of the type typically operated in Bangladesh, has been analyzed. A strongly jeopardizing effect of the overloading on intact ship condition has been detected when analyzing the hazard of crowding of passengers to one side.

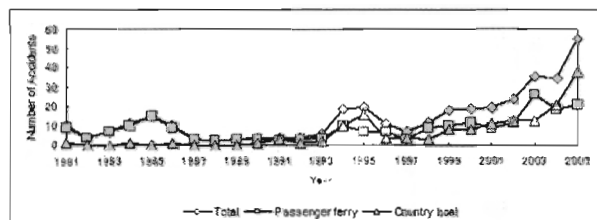
Data for a total of 359 passenger water transport accidents were collected in the period 1981-2005, in which passenger ferries (locally called as "launch") were involved in 219 occurrences, where small sized country boats' and trawlers' involvement was found in 159 cases. The numbers add up to 378 (and not 359) because in some collision cases both launch and boats/trawlers were involved. Figure 1 shows the year-wise distribution of the number of accidents.

Figure 1: Number of accidents during 1981 to 2005.
