A rational analysis of intact stability hazards involving small inland passenger ferries in Bangladesh

Abstract The safety of inland passenger vessels operating in Bangladesh has been investigated. By thorough analysis of past accident data, the main causes of intact stability failures have been determined: adverse weather conditions and overloading, likely resulting in crowding to one side. Historical series of wind data were gathered and their analysis suggests that an increase in the wind speed presently used in the Weather Criterion in force in Bangladesh could be advisable. A model of a small passenger ship typically operated in Bangladesh has been analyzed in order to identify the most relevant hazards under intact ship conditions. A strongly jeopardizing effect of overloading under intact ship conditions has been detected when analyzing the hazard from the crowding of people to one side.

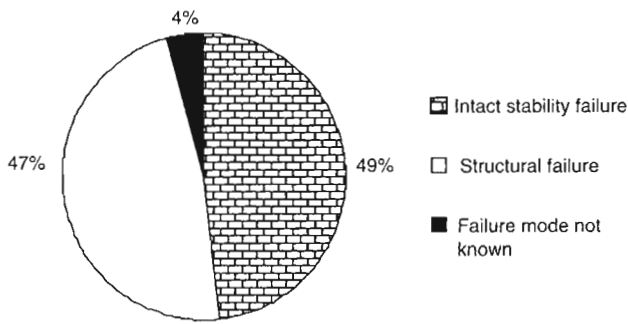
Fig. 3 Proportions of passenger ferry accidents caused by various failure modes

The mode of failure, the loading conditions and the weather conditions during the intact stability failures of ferries are shown in Figs. 3 and 4, 5.

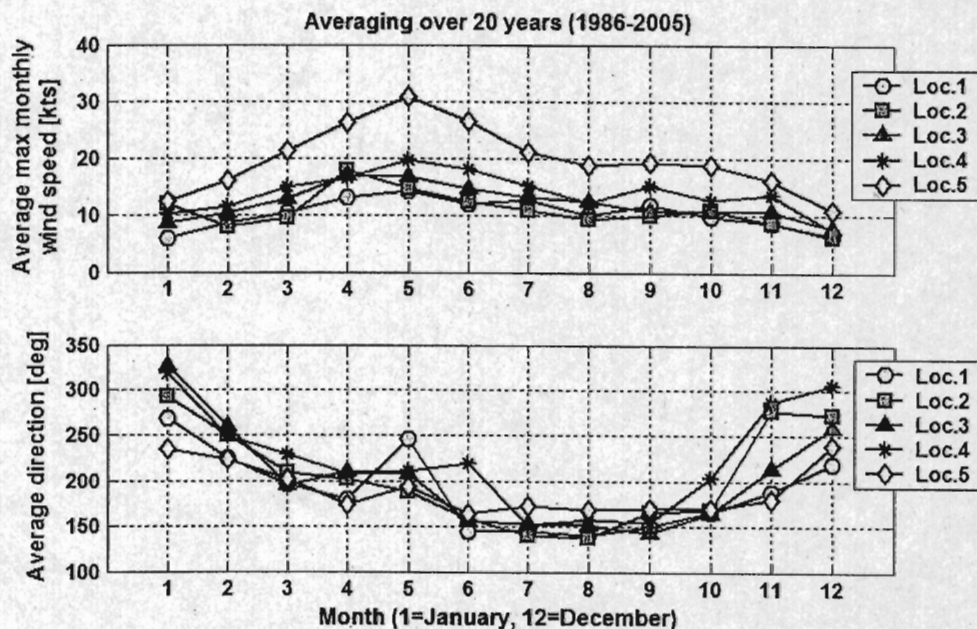
Station name: Dhaka, latitude 23°46'N, longitude 90°23'E; monthly maximum wind speeds (spd) in knots and directions (dir) in degrees

Fig. 7 Average monthly maximum wind speed and corresponding direction in the period 1986–2005 for the five available locations

As a first analysis, we hunted for seasonal trends in the sample data. To do so, the average monthly maximum speeds and directions for the 20 years available were determined for each location, as shown in Fig. 7. From the reported analysis, the period between April and June appears to be the most critical period for all of the available locations, meaning that sailing during this period is expected to be more dangerous than sailing during the other months of the year, at least when only the wind is of concern. April to June is the period when a series of Nor'westers (the local name for typical, small localized

location is considered together with the possible sheltering effect of surrounding hills and mountains. It is also clear from the analysis that Location 5, Chittagong, shows an unusually high average maximum wind speed, while the other locations show comparable behavior with significantly lower average maximum monthly wind speeds. This is likely due to the fact that Chittagong is not an inland location, unlike all the other available locations, as can be seen from the map in Fig. 6. It is, instead, a city facing the Bay of Bengal, i.e., (almost) the open sea.

First of all, we consider the ship to be operated throughout the year, and in addition we assume the ship to be operated in an unknown location in Bangladesh's National Waters. According to these assumptions, we can combine the observations of the monthly maximum wind speed for all the different locations and for all the available months and consider them as possible outcomes of the monthly maximum wind speed experienced by a ship operated in Bangladesh. By combining all of the data concerning the monthly maximum wind speed for all the locations, we obtain the probability density function and the corresponding cumulative distribution, as shown in Fig. 8. The variability of the CDF among different locations is shown in Fig. 9. In Fig. 8, the effect of neglecting the data coming from Location 5 is considered. The maximum measured wind speed over the 20 years among the five locations was 90 knots, and it occurred twice: at Location 2 in April 1998 and at Location 5 in May 1997. Due to the fact that the empirical CDF estimated for the maximum available from the sample is equal to one, this point does not appear in the logarithmic representations of Figs. 8 and 9. In all of the other cases, the maximum wind speed was below 64 knots (experienced once at Location 4 in November 1988). We can see that taking into account the data from the coastal Location 5 leads to a general increase in the probability that a given maximum wind speed will be exceeded, due to the more severe wind, as already pointed out when discussing Fig. 7. However, the differences in the

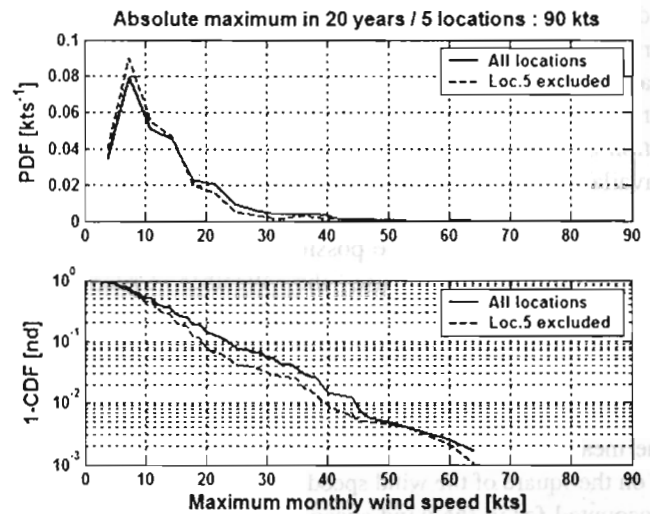
Fig. 8 Estimated PDF and probability (1-CDF) of exceeding the maximum monthly wind speed experienced. All months have been joined

If we assume 10^{-3} to be an acceptable level for the probability of exceedance of the monthly maximum wind speed for intact stability assessment, we can estimate from Fig. 8 a corresponding maximum wind speed of ~ 65 knots, i.e., about 33 m/s. Such a level of probability can be translated into an approximated annual probability of exceedance, assuming independence among different months, of about 0.01 [i.e., $1 - (1 - 10^{-3})^{12}$]. It should be noted that such a probability could still be considered to be too high in a safety framework, and so a higher speed (corresponding to, e.g., a 10^{-4} probability level) may be more appropriate.

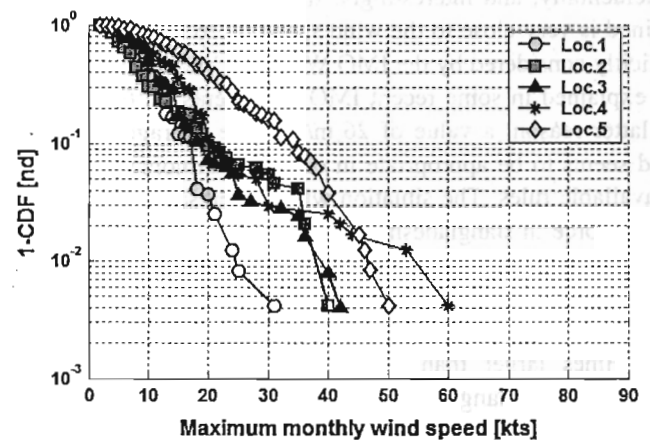
Fig. 9 Estimated probability that the maximum monthly wind speed experienced will be exceeded for the different available locations. All months have been joined

range of speeds above 50 knots seem to be limited (even if, due to the limited amount of data in this region of the CDF, the confidence in the estimation is not very high).

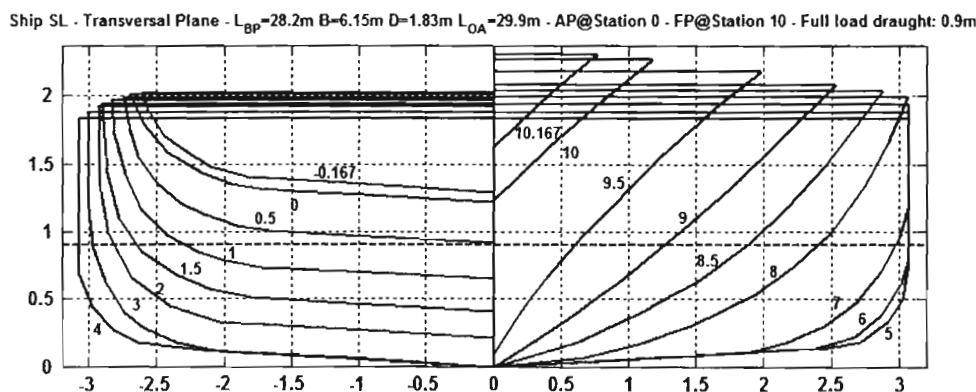
Fig. 10 Bodyplan of the ship SL

The bodyplan of the ship SL is reported in Fig. 10. Data for the two loading conditions and the main particulars of the ship are reported in Table 3. In Table 3, two values are reported for each loading condition, for the lateral projected area. The smaller value is the lateral projected area reported for the basic ship, as found in the available documentation, and it corresponds to the actual lateral projected area considering the presence of the openings on the side. The higher value given in parentheses is the estimated lateral projected area considering the presence of curtains (often installed to protect passengers from rain and wind) over the openings. The estimation was performed by considering the general plans of the similar ship. The wind lever Z was assumed to be the same whether curtains or clear openings were present.

It is important to report a series of comments, before proceeding, on the position of the draught in the loading condition referred as "full load." As is clear from the bodyplan in Fig. 10, such a draught is well below the draught corresponding to the position of the perpendiculars. Indeed, from the available drawings, the maximum allowed draught for the modified (scaled) ship would be 1.20 m, i.e., 0.3 m more than the considered "full load." Such a difference corresponds to a difference in displacement of about 42 t. The basic ship considered here is allowed to carry, in addition to passengers, a limited quantity of cargo (around 7 t). However, the absence of such a quantity of cargo cannot justify the difference in the draught. Unfortunately, this matter is not discussed in the report on the investigation into the capsizing of the ship from which we have gathered the information on the loading conditions, and thus it is not clear whether the loading conditions reported in Table 3 should actually be supplemented with some other loading condition in order to reach the maximum allowed draught. Also, it is difficult to imagine such a loading condition, due to the fact that the sum of the lightship weight, the maximum number of passengers allowed, the maximum cargo allowed, plus some other items (water, fuel, etc.) cannot reach the displacement at the maximum allowed draught, and a considerable amount of ballast (around 35 t) would be needed. Based on these considerations, the results obtained by considering only the two aforementioned loading conditions should be considered with care, and a more thorough investigation of the actual operation of the ship that capsized, and of similar ships, should be carried out.

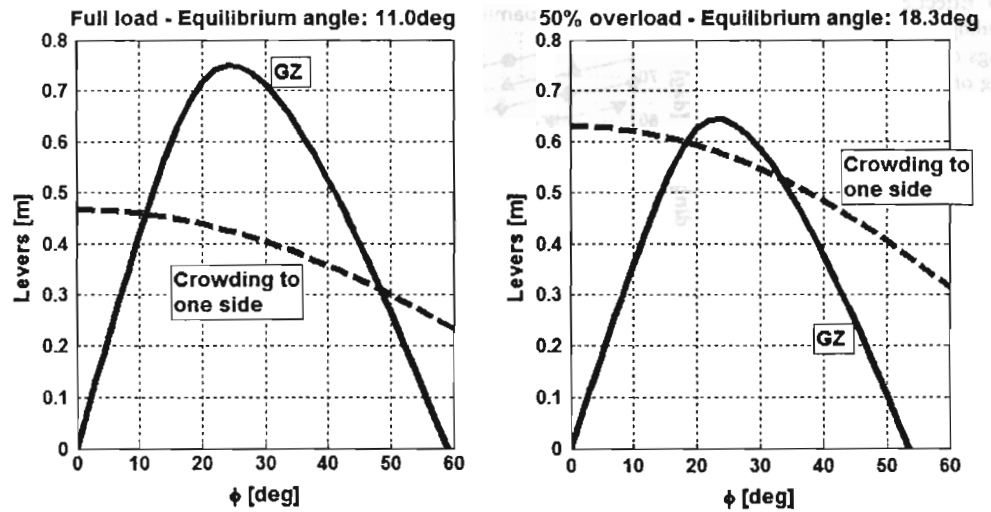
Fig. 11 Restoring and heeling moments due to passenger crowding

A comparison between the assumed heeling lever due to crowding and the righting arm is reported in Fig. 11. The heeling moment due to passengers crowding to one side is significant, due, as already mentioned, to the large ratio between the passengers' weight and the ship displacement. Under the full load condition, however, the ship shows a quite large range of residual stability above the angle of equilibrium, suggesting that the crowding hazard under the full load condition, although important, is not extreme. The same cannot be said of the overloaded condition, where the increased weight of the passengers onboard leads to an equilibrium angle of more than 18°, and, more importantly, to a residual range of stability that is very small, as well as the maximum residual \overline{GZ} . This means that, under the overloaded condition, the ship is in extreme danger from the crowding of passengers to one side if some additional cause of heeling, like the expected presence of wind, is introduced. It should be noted that, due to the very large B/T ratio of the ship under analysis, the \overline{GZ} curve shows, in both cases, a maximum at relatively small heeling angles, despite the very large metacentric height.

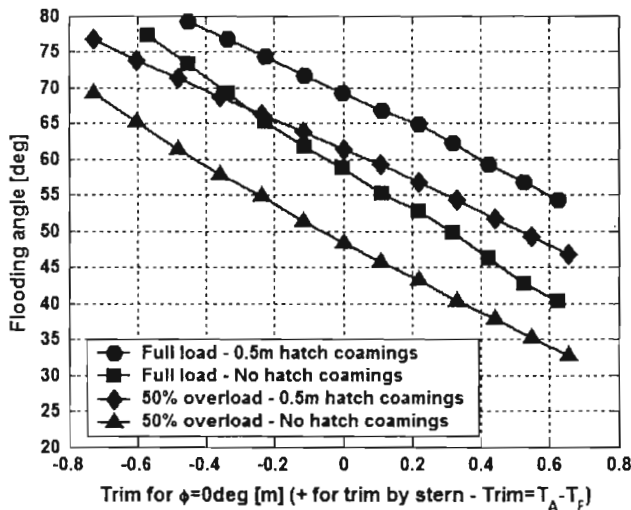
Fig. 13 Angle of submergence of the hatch leading to flooding of the engine room in case of the absence of the hatch cover

assuming the absence of the hatch cover. The analysis was carried out for the two loading conditions, considering the effect of the presence of hatch coamings with a representative height of 0.5 m above the main deck, and investigating the effect of the initial trim. From the results shown in Fig. 13, a series of comments can be made:

- The angle of flooding under the full load condition is large enough to consider the flooding of the engine room to be an unlikely hazard with or without the presence of hatch coamings.

- The angle of flooding shows a significant decrease in the 50% overloaded condition. Under this condition, the fitting of hatch coamings is an effective means of increasing the downflooding angle.

- We can see that, for the zero trim condition, the flooding angle ranges from about 70° in the case of a fully loaded ship with hatch coamings 0.5 m in height, to about 48° in the case of the 50% overloaded condition without hatch coamings. This means that the tested ship, operated within the expected range of draughts, is unlikely to risk flooding the engine room even if the hatch cover is not present.

- For the tested cases the downflooding angle is always in the range of descending \overline{GZ} , and in many cases even in the range of negative \overline{GZ} , meaning that the flooding of the engine room under the effect of steady heeling moments can only occur if the ship has already reached an unstable condition, eventually leading to capsizing.

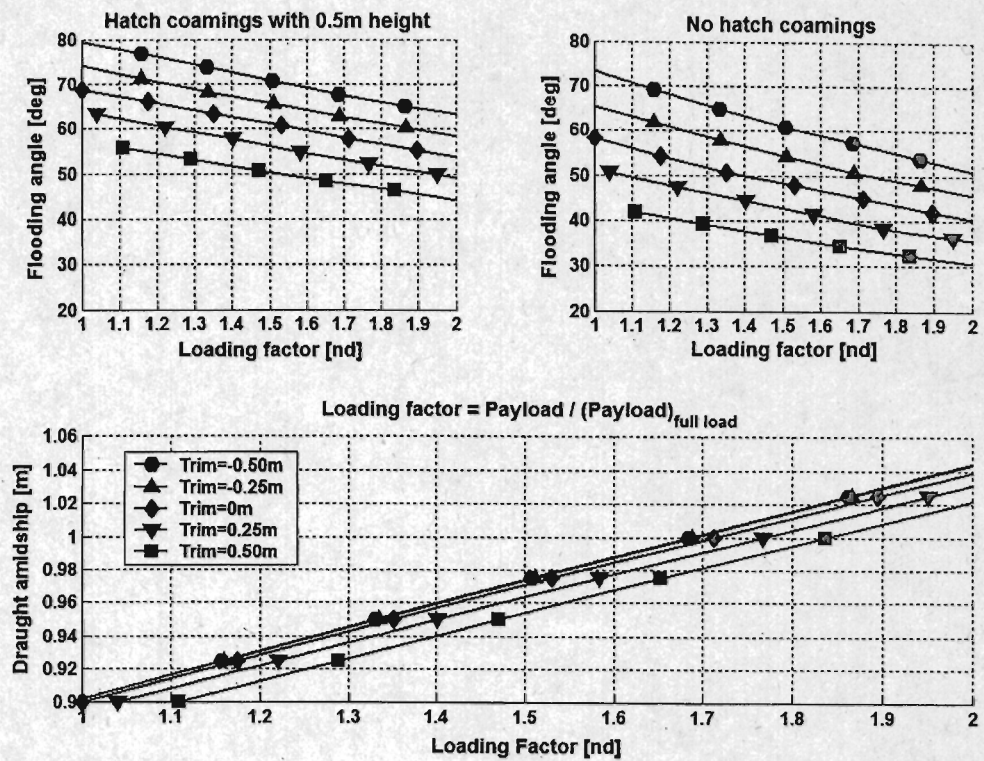
Fig. 14 Effect of the overloading, trim and hatch coamings on the angle of flooding of the engine room

In order to assess the effect of overloading on the risk of flooding the engine room, the downflooding angle has been calculated for a series of overloaded conditions up to 100% overloading (a condition unfortunately not uncommon in Bangladesh), and for a series of trims in the upright position, with and without the presence of hatch coamings. The results are reported in Fig. 14. In the worst cases characterized by large overloading, significant trim by stern and an absence of hatch coamings, the possibility of flooding the engine room in the case of large rolling angles increases. However, if the trim by stern is not excessive, the flooding of the engine room occurs at significantly large angles, even in the case of 100% overloading. It is interesting to note that the fitting of the hatch coamings reduces the loss in the downflooding limit given by the effect of trim.

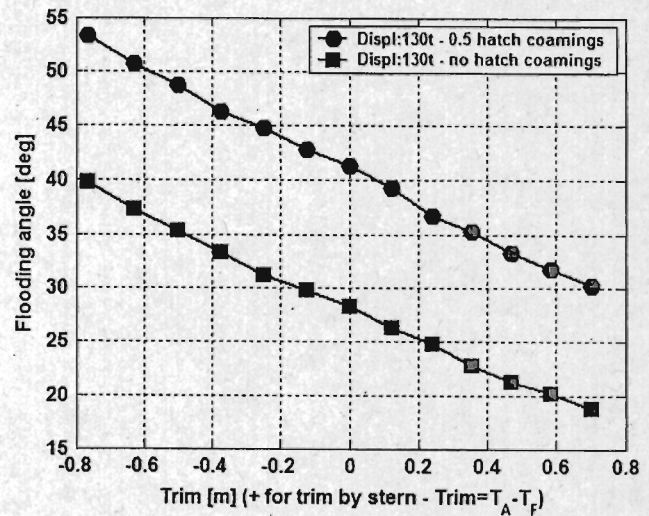
Fig. 15 Downflooding angle for the maximum allowed displacement of 130 t as a function of trim, with and without the presence of hatch coamings

As already reported, we have some concerns regarding the actual draught at which such a ship could actually be operated, irrespective of the limits imposed by the rules. For this reason we have performed an additional calculation of the downflooding angle for the engine room, with and without hatch coamings, for a displacement of 130 t (corresponding to the maximum allowed draught of 1.2 m with zero trim) accounting for the effect of trim. The results are shown in Fig. 15.

We can see that, due to the reduced freeboard, the angle of downflooding is now significantly reduced, especially in the absence of hatch coamings and when there is significant

trim by stern. The hazard related to the flooding of the engine room starts to become significant for the displacement represented by Fig. 15.

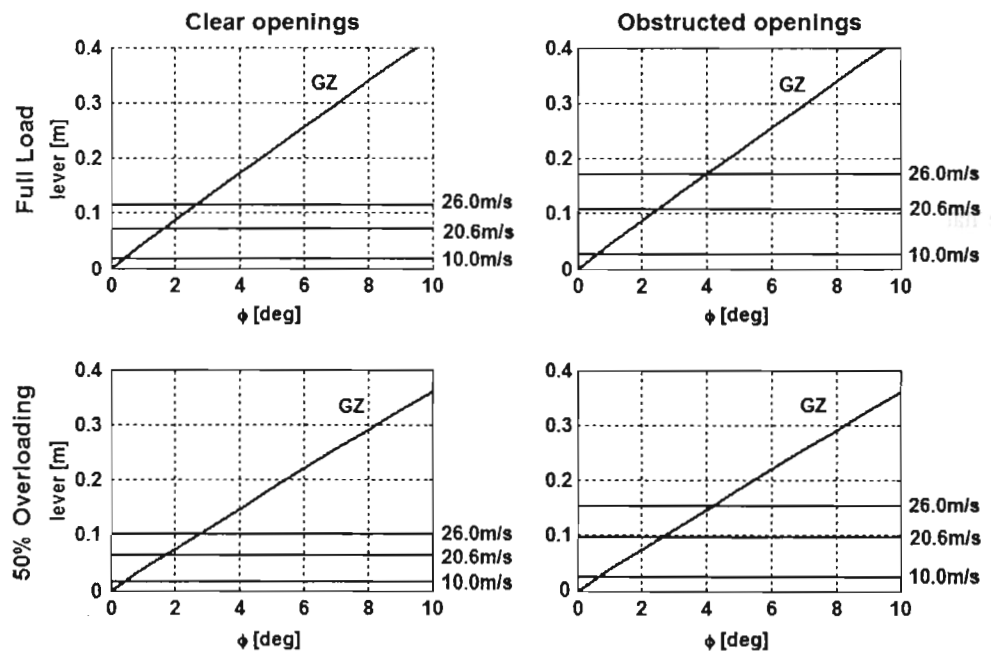
Fig. 16 Analysis of the effect of beam steady wind

The results of the analysis are reported in Fig. 16. We see that the effect of the wind is, despite the relatively large

exposed area, not very significant, and the equilibrium angle in the worst case considered slightly exceeds 4° . This is due to the large metacentric height in the loading conditions considered.

For not too extreme speeds, the wind itself does not seem to be a very dangerous hazard that is able to capsize the ship. Nevertheless, it is important to pay attention to the large variation in the heeling moment due to the wind, depending on the assumptions used. The ratio between the exposed area with obstructed openings and the area with clear openings is about 1.5, meaning that, if we consider the openings to be obstructed, the heeling lever due to wind is 50% more than in the case with clear openings. This results in a $\sim 50\%$ increase in the equilibrium angle, thanks to the linearity of \overline{GZ} at small heeling angles. In addition, if we compare the case with a wind speed of 10 m/s with the case with a wind speed of 26 m/s, a factor of 6.8 is found in relation to the heeling levers and thus, approximately, the corresponding angles. If we compare the assumptions of 20.6 and 26 m/s, the ratio between the corresponding heeling levers is 1.6. Globally, if we consider the best and the worst case, we find a ratio of about 10.2 between the corresponding heeling levers, and thus, approximately, the corresponding heeling angles. In view of the analysis of the wind carried out in this research, and considering the relatively common bad habit of fixing the curtains at the side openings, it would seem more reasonable to consider the openings to be obstructed and thus a wind speed of 26 m/s within the framework of the stability assessment.
